## ***Jusuf Mašković's Inn, Vrana***

Name of organization  
compiling the information:  
Ministry of Culture,  
Conservation Department in Zadar

Name and address of building or site: JUSUF MAŠKOVIĆ'S INN, VRANA

Building(s) type: caravanserai

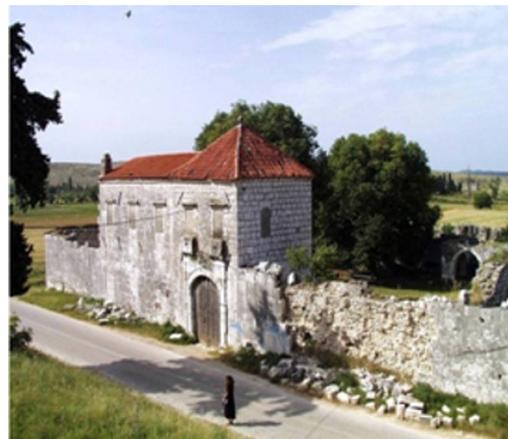
Poor – deteriorating structure and/or leaking roof; outbreaks of rot; general internal deterioration; partly affected by fire or disaster

Roof more than 30% damage, with significant damage to walls, but can be repaired

Today, Mašković's Inn is in a very poor state. Centuries old neglect and inadequate use have caused degradation that has accelerated in the last few years. The Inn was built from finely cut stone blocks which are falling out and disappearing, the spaces within the complex are being filled up with earth causing the excessive growth of vegetation whose roots are

destroying the walls. The roof over the main residential building is in poor repair so that humidity has almost completely destroyed the first floor.

The structure is severely threatened given that the binder, i.e., plaster, has lost its properties. For that reason the heavy rains from a few years back caused the sliding of over 30m<sup>2</sup> of the enclosing wall built from dressed stones.
