Historical building City hall in Novi Grad

Name of organisation
compiling the information:
Commission to Preserve
National Monuments

HISTORICAL BUILDING CITY HALL in
Novi Grad, Bosanski Novi

Provisional List of National Monuments
No.:116

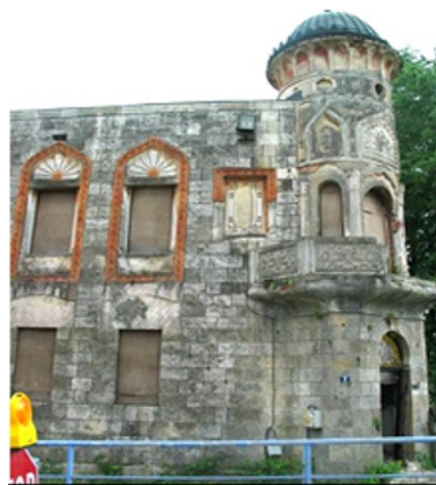
Very bad: Two of the load-bearing walls of the building have collapsed, parts of the roof structure and roof cladding are cracked, and all the woodwork is damaged. Large cracks are visible on the facade of the building. The building has been out of use since 1995 as a result of this serious damage.

Suffered more than 30% of roof damage, with significant damage of walls, but can be repaired.

A project for urgent protection measures from further deterioration needs to be prepared, as well as projects for the next phase of protection – project of sanitation, conservation and restoration.

- structural repair and restoration to its original appearance with all the structural elements of the building as they were: roof, foundations, walls, ceilings, and all interior and exterior elements;

- the structural repairs and restoration shall be carried out by consolidation of existing material or its replacement by material of the same type, same dimensions and form with the use of the same building techniques wherever possible, on the basis of documentation on its original form ;

- prior to the start of structural restoration works the structural stability of the building shall be studied;
- structural consolidation of all walls and structural elements;

- consolidation of existing cut stones by injection or replacement by identical cut stones;
- structural repairs to all floor and roof structures, replacing age-dilapidated material with the same material of the same dimensions, worked in the same way and using the same techniques;

- restore authentic arrangement;
- plaster all interior walls with lime plaster made using old methods and whitewash all walls;
- repair all woodwork, replace rotten parts and treat with natural protective substances;
