The Great Synagogue

THE GREAT SYNAGOGUE
Sinagogilor Str., IAȘI
MUNICIPALITY, Iasi county

Sacral building, Synagogue

1671 – 1682

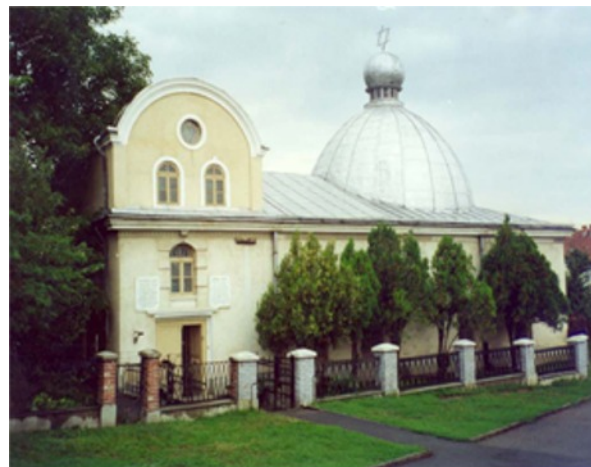
Poor: deteriorating structure and general internal deterioration.

Today, the edifice shows serious structural damages: cracks and fissures in the walls and the arching system, decay (putrefaction) of the framework and structure of the wooden cupola, exfoliation of the stone in the foundation and walls, decay of the finishing elements.

Consolidation works are necessary for the walls and foundation, the arching system, as well as for reconstruction of the floors and the framework and replacement of the zinc plate cover. The restoration proposed by the project aims to maintain the synagogue's image, which has become a symbol of the urban scenery. The solution adopted is oriented towards the authentic and the return to the original image.
