The Wooden Church – Răstolnița
The Wooden Church – Oroiu
The Wooden church - Lunca Mureșului

THE VALLEY OF MUREȘ
 THE WOODEN CHURCH – RĂSTOLNIȚA
 Mureș county
 THE WOODEN CHURCH – OROIU
 Mureș county
 THE WOODEN CHURCH - LUNCA
 MUREȘULUI
 Alba county

Orthodox wooden churches

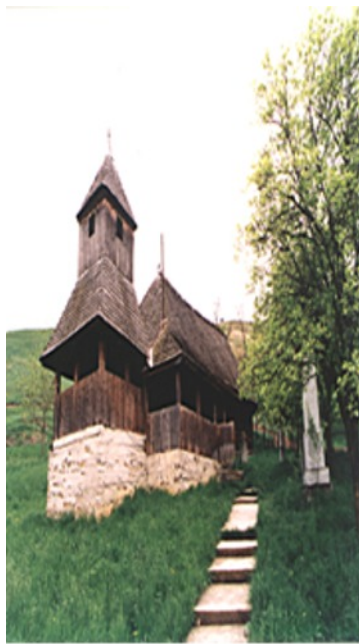
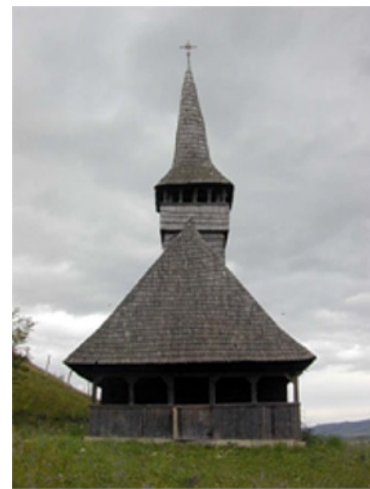
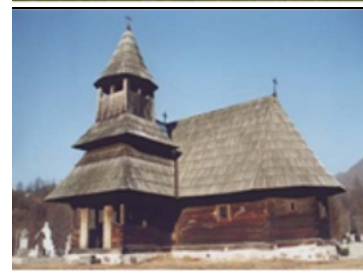
The wooden structure is very damaged. General internal deterioration, especially the paintings.

- consolidation of the wooden structure
- new roof
- special works for conservation and the restoring of the beautiful painting
