Episcopal Palace, Pakrac

<u>Name and address of building or site:</u>	EPISCOPAL PALACE IN PAKRAC
<u>Inventory reference number:</u>	Z – 401
<u>Building(s) type:</u>	Representative sacral-residential building
<u>Main date(s):</u>	Built in 1732
<u>Current use(s):</u>	The building is in ruins - not in use
<u>Significance:</u>

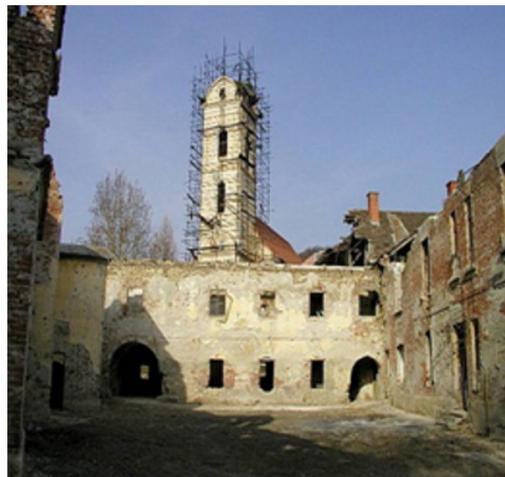
The building of the Eparchial palace is in exceptionally poor condition. The roof construction is almost completely destroyed as well as the roof structures over the ground and first floors. The vaults over the ground floor have almost completely caved in and the courtyard wall of the building is very slanted threaten to collapse.

More than 90% of the roof is damaged; walls severely damaged - reconstruction still possible.

The Episcopal Palace in Pakrac is the historical centre of the Serbian Orthodox Church in Slavonia. It is an exceptionally complex structure with a number of developmental phases. After the war damages to the structure were not repaired in due time and atmospheric effects have turned it into ruins. After initial works of surveying the terrain and clearing it of mines, the clearing of the fallen parts of the roofing and ceiling constructions, vaults and walls was undertaken. Precisely because of that it is necessary to begin work on the remediation of walls and vaults as soon as possible in order to prevent further deterioration.
