## ***Eltz Manor, Vukovar***

Name of organization  
compiling the information:  
Ministry of Culture,  
Conservation Department Osijek

Name and address of building or site: ELTZ MANOR, ŽUPANIJSKA 2, VUKOVAR

Building(s) type: Civic structure – manor

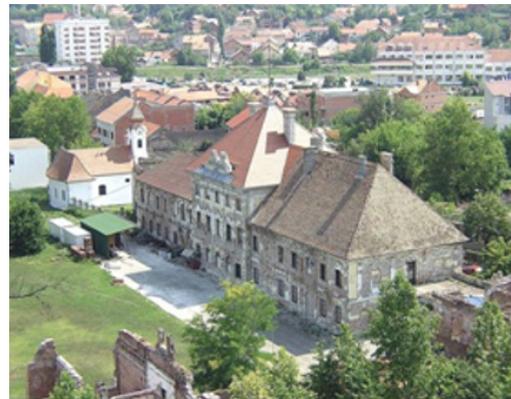
The entire complex was barbarically destroyed during the siege of the city in the fall of 1991, and the process of devastation continued during the temporary occupation. The interior of the manor was particularly severely damaged. It continued to deteriorate due to the impossibility of timely renovation. Part of the outer carpentry and stone plastics has also been destroyed.

Poor - dilapidation of the construction, damaged roofing, partial damages to the building as a result of war devastation

More than 30% of the roof damaged; severe damage to walls - renovation possible

The endangered state caused by war devastations is continuously decreasing given that to date a temporary roof has been constructed over the north-east wing and the roof over the central part of the manor has been permanently repaired.

The condition of the Eltz Manor given war damage is quite difficult and the elaboration of the master plan of its renovation is under preparation. In order to alleviate the risk a temporary roof has been placed over the northeast wing and the roof over the central part of the Manor has been permanently repaired.
