Church of the Dormition of the Holy Mother of God

CHURCH OF THE DORMITION OF THE HOLY MOTHER OF GOD, village of Velushina

Orthodox Church

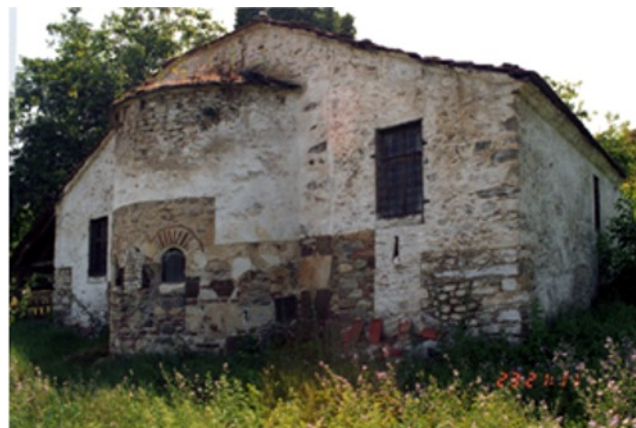
The building is a small three-aisled basilica, inspired by early Christian architectural typologies. Studies have proved that the communication from the central aisle to the subsidiary aisles and the narthex was ensured through a triple passage (*tribilon*). This type of passage can be found in the several sacral Byzantine buildings, built in the 9th -11th centuries, such as the monastery of Chora in Constantinople, St. Sophia in Thessalonica and the Church of the Dormition of the Holy Mother of God in Labovo (Albania). This type of "small basilica" is characteristic of the regions of Kastoria and Florina in Greece. Other very similar examples are the Church "Taxiarhi" in Castoria, built in the 9th century, the Church of the Dormition of the Holy Mother of God in Kalambaka, in the region of Thesalia, and the

Very bad: structure failure and instability, the roof is seriously damaged.

Immediate risk of rapid deterioration. A detailed proposal for the construction of a temporary roof as a priority measure was prepared but it was not implemented because of insufficient financial support.
