## St. Nicolas Church

ST. NICOLAS CHURCH, Upper  
Krutja, Lushnja.

Architectural monument, church

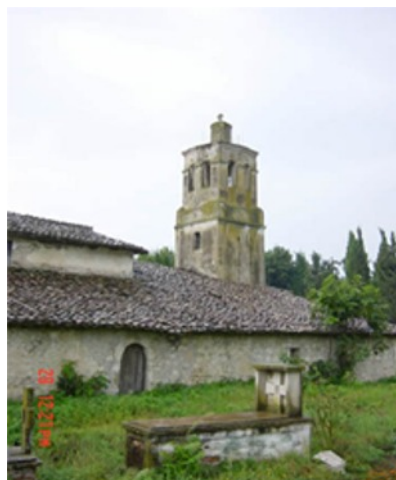
Poor: deterioration of the masonry. Due to damage of the supporting structure of the roof, the walls in the southern and northern parts deviate from the vertical position. Mural paintings are damaged by roof leaks.
