Jashar Pasha Mosque

Institute for Protection of
Monuments of Kosovo

JASHAR PASHA MOSQUE, Pristina

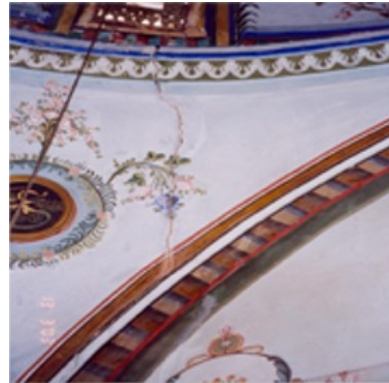
Poor: The condition of the Jashar Pasha Mosque is not good. There are cracks in constructive elements and the condition of the stone is not good. The historical environment is degrading.

If we do not undertake measures needed for the sanitation of the monument, including the conservation and restoration interventions, the mosque will be at risk of further destruction.
