Historical building Eminagića's konak

Name and address of bulding(s) or site: HISTORICAL BUILDING EMINAGIĆA'S
KONAK (guest house), Tešanj

Inventory reference number(s): Provisional List of National Monuments
No.:618

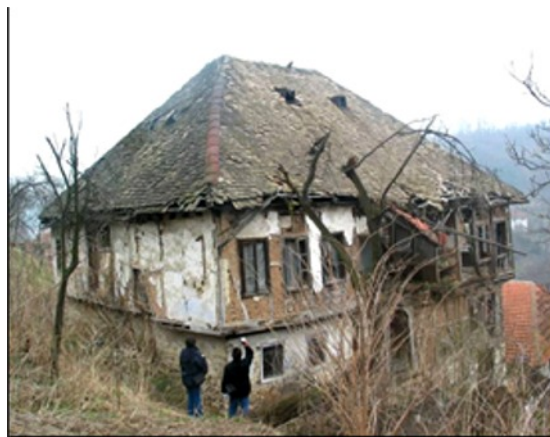
Very bad

The house is at risk of rapid deterioration as a result of lack of regular maintenance. The Eminagić house is endangered by many years lack of maintenance and failure to undertake even minimal protection measures. It is very likely that damage from elements will lead to the destruction of the entire building.

A project of urgent protection measures to prevent further deterioration needs to be done, as well as projects for next phases of protection – sanitation, conservation and restoration.

- shall be structurally repaired and restored to its original appearance with all the structural elements of the building as they were: roof, foundations, walls, ceilings, and all interior elements
